## CP6 Year 4 - SCM3 - Cowie Embankment

### GPS and UAV Drone LiDAR / Photogrammetry Works

**Location:** SCM3 - Scotland

**Client:** Network Rail

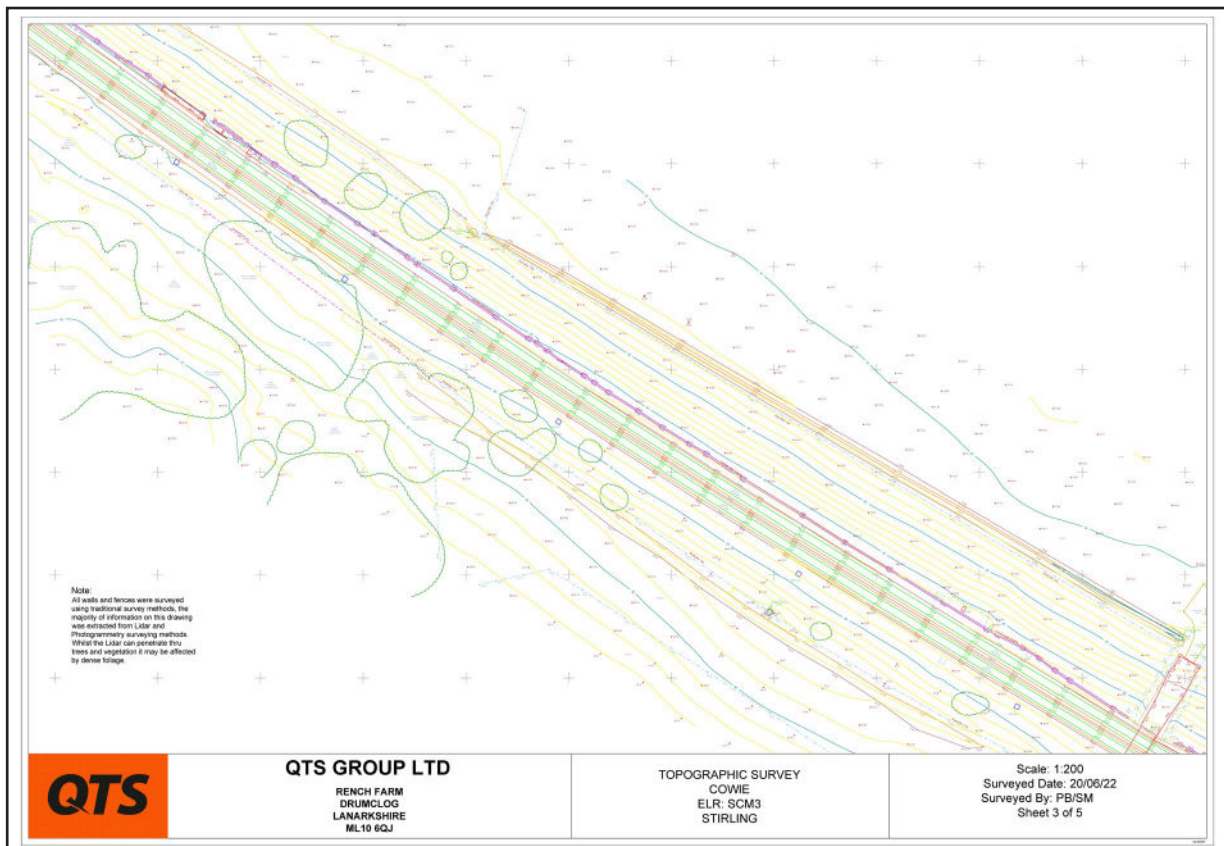
All data was downloaded onto separate software packages and manipulated by the surveyor to produce a final Autocad drawing, which was then sent on to the design team. The GPS data was used to confirm boundary lines and drainage features as described previously. LiDAR data was used alongside the photogrammetry data set, to create a full 3D model of the entire site. Accurate ground levels and features were able to be pulled from areas covered in dense vegetation in a matter of minutes, which would have taken a lot longer to gain out in the field using traditional methods. No surveyors were required to set foot on any steep slopes. Use of the drone on this project resulted in works being completed faster and safer without accuracy being compromised in any way. In addition to this, if any further detail is required in area, there's a good chance this will already have been captured.
